# Case Study Water Point Failure Uganda

[Africa Groundwater Atlas](#) >> [Additional resources](#) >> [Case studies](#) >> Case study: Reasons for water borehole failure in Uganda

## A local-level study of water boreholes failure in Uganda

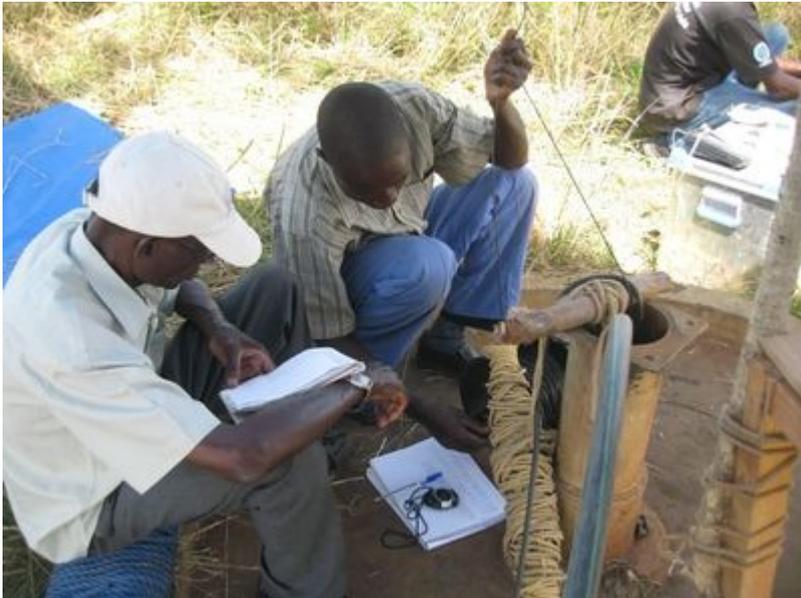
- The main observed problem was insufficient yield.
- Pumping tests carried out during the technical survey showed that the aquifer had low transmissivity.
- CCTV borehole inspection showed inflows of shallow groundwater through borehole casing joints from the weathered regolith aquifer, but the borehole had not been designed to include a screen within the weathered regolith, so most shallow groundwater wasn't reaching the borehole.
- It was unclear from community discussions how the pump had been sited, and by who.

Carrying out a pumping test on a failed borehole in Amuria District. Image credit: [Bonsor et al. 2013](#)

The conclusion is that this borehole was not designed or constructed in an optimum way. If it had been sited in a more productive part of the aquifer, and/or the borehole screen had been installed to allow inflow from the weathered regolith zone of the aquifer, the water point may not have failed.

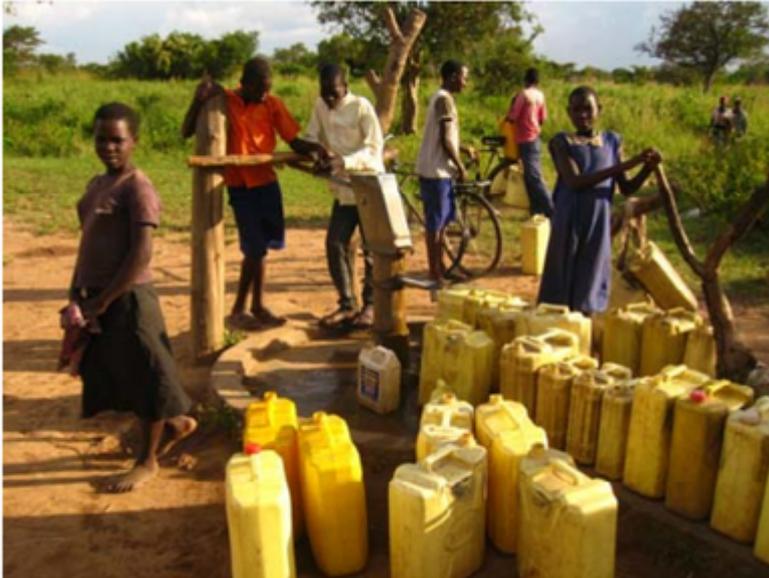
High demand on water points in Amuria District is just one of the complex set of interlinked factors that can lead to water point failure. Image credit: [Bonsor et al. 2013](#)

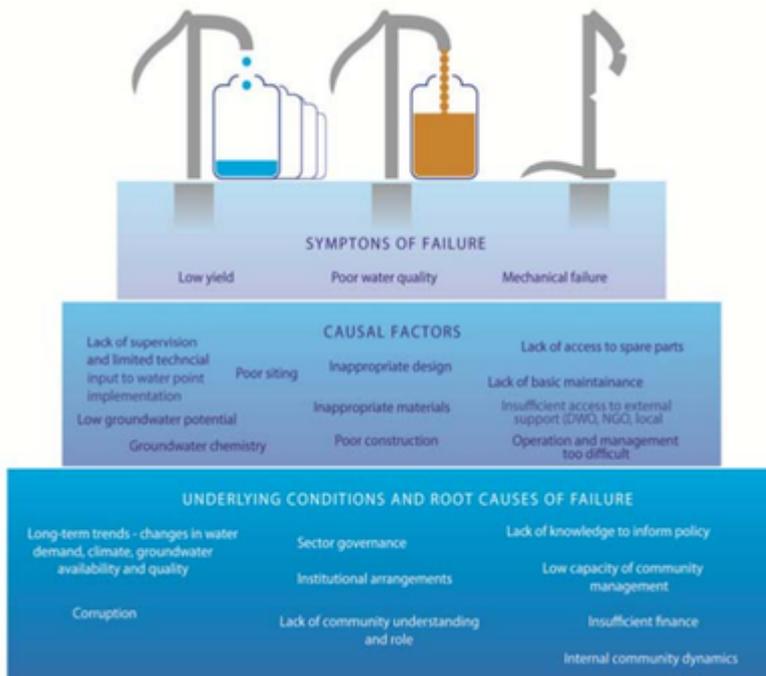
Hierarchy of symptoms, causal factors and underlying causes of groundwater source failure. Image credit: Figure source: [Bonsor et al. 2013](#)
