Building stones of Edinburgh: use and availability of sandstones

From: McMillan, A.A., Gillanders, R.J. and Fairhurst, J.A. 1999 [Building stones of Edinburgh](#). Edinburgh: Edinburgh Geological Society.

The use and availability of sandstone in Edinburgh

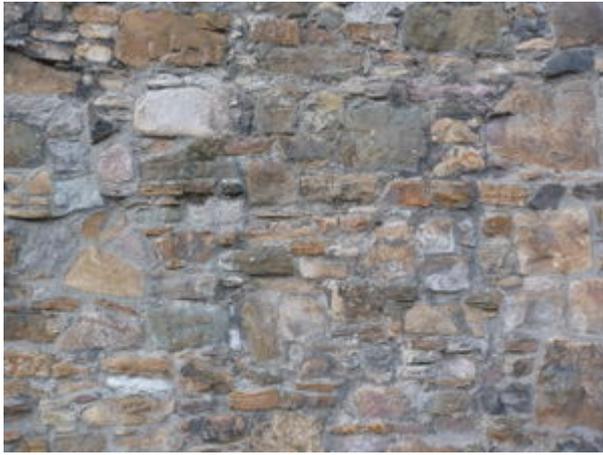
Telfer Wall, the Vennel, Lauriston Place. An extension of Flodden Wall to incorporate George Heriot's Hospital. Rubble construction mainly of local sandstones. Built 1628-1636.

Sandstone has been built into structures in a variety of ways. When stones have little or no work done on them after they come from the quarry, they are described as rubble. The broken pieces of stone, often of varying shape and size may be built as random rubble walls as in the Flodden Wall at the **Vennel** [32]. Early tenements were also rubble-built and **No. 7 West Nicolson Street** is a fine late 18th century example. An example of a modern rubble wall may be seen on the south side of Holyrood Park Road near the **Commonwealth Pool**. Rubble walls are relatively cheap to construct and may be built either uncoursed or in courses. Stones are taken more or less at random and built to form the strongest bonds across and vertically in the wall with no attempt to form accurate vertical or horizontal joints. Large stones are flat bedded and packed or wedged up with smaller stones. Joints are well filled with mortar and where these joints on the face are large they are packed with small stones driven into the gaps. The strength in these walls depends largely on the mortar.

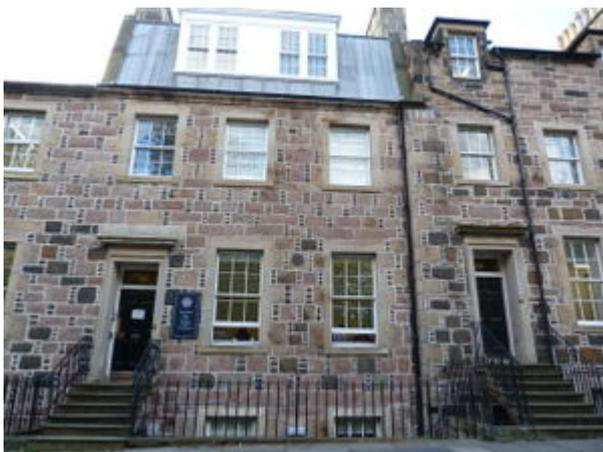
No. 21 George Square (west side), Edinburgh. Pink Craigmillar sandstone with cherrycock pointing and black dolerite snecks. Built in 1767-1774.

Where stone can be quarried from thin beds in the quarry or where thick beds are easily split into smaller pieces the rubble can often be readily cut into squares. Such squared rubble, also known as square-snecked rubble, can then be built into uncoursed walls in irregular patterns involving units of four stones (a large stone known as a riser or jumper, two thinner stones called levellers and a

smaller stone, a check or sneck). When the rubble is levelled up to form courses 300-450mm (12-18 inches) deep coursed squared rubble is produced (Figures 6.1c-d). The squared rubble can be brought to courses of varying depths with some of the stones at course height and smaller stones tilling in the spaces. Figure 6.1d shows a good example of snecked squared rubble at **Marischal Place**, Blackhall. In regularly coursed squared rubble the courses are again of varying height but the stones in any one course are all of the same height. A decorative variation of this style of walling is seen in some of the surviving buildings on the west side of **George Square** [43] where some wider vertical joints have a series of black dolerite snecks in them.

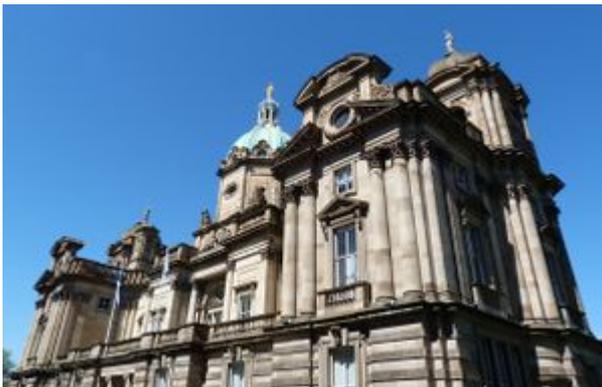
The Bank of Scotland on the Mound.
Vermiculated work can be seen in bands at the base of the photo.

This finish produces a continuous winding pattern slightly raised above the inner area of the stone. An example can be seen on the south side of the **Bank of Scotland** [13] on the Mound.
