Case Study Acid Mine Drainage South Africa

[Africa Groundwater Atlas](#) >> [Additional resources](#) >> [Case studies](#) >> Case study: Acid mine drainage in South Africa

Acid mine drainage in Gauteng Province, South Africa

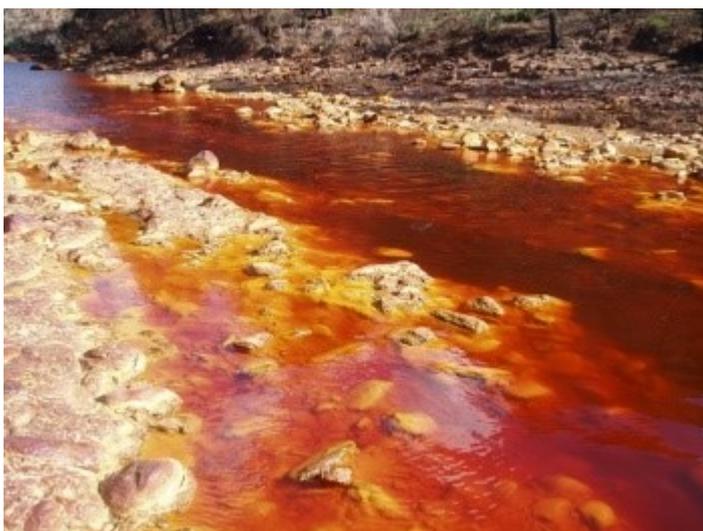
An example of acid mine drainage. Image credit: <http://www.infrastructurene.ws/2016/04/25/gauteng-municipalities-to-fork-out-r3-3-billion-for-acid-water/>

Eventually, the groundwater level in the mines can rise to a level where it flows out at the ground surface - for example, via natural fractures into a stream, or via worked tunnels. The interconnected nature of the mines and the hydrogeological system in this area, which is not well understood, means such discharges are unpredictable. The burden of dealing with mining-induced poor quality groundwater and acid mine drainage, has largely fallen on the mining companies that remained operational in the region.

The first discharges of acid mine drainage in Gauteng Province happened in 2002 in the Western basin, at various locations including a well that was not previously known to be connected to the mine system. This highlights the unpredictable nature of the problem in an area where the hydrogeology is poorly understood.
