File:YGS CHR 08 IMAG FIG 09.jpg

Carboniferous hydrocarbon resources: the southern North Sea and surrounding onshore areas

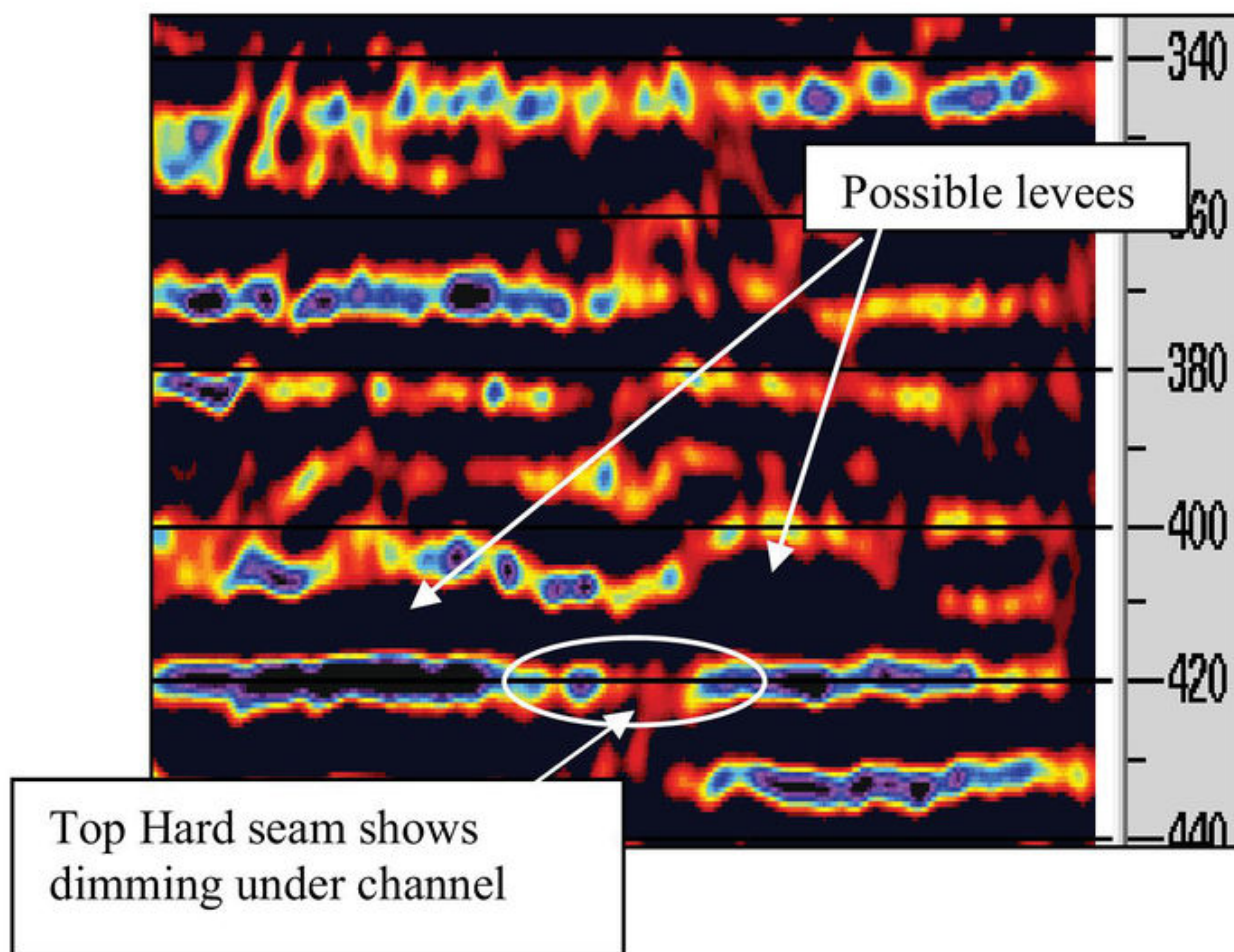
description	English: Figure 9 Channel feature above the Top Hard seam. The Top Hard seam, at 420ms TWT, shows a dimming in reflection strength, indicating a possible thinning of the seam. The cross section of the channel feature appears to have banks or levees. From: Carboniferous hydrocarbon resources: the southern North Sea and surrounding onshore areas , edited by J. D. Collinson, D. J. Evans, D. W. Holliday, N. S. Jones. Published as volume 7 in the Occasional Publications series of the Yorkshire Geological Society , Copyright Yorkshire Geological Society 2005.
source	Yorkshire Geological Society
author	B.A. McGlen and J.H. Rippon
